MORPHOLOGICAL MANAGEMENT IN ESTUARIES CONCILIATING NATURE PRESERVATION AND PORT ACCESSIBILITY

Abstract

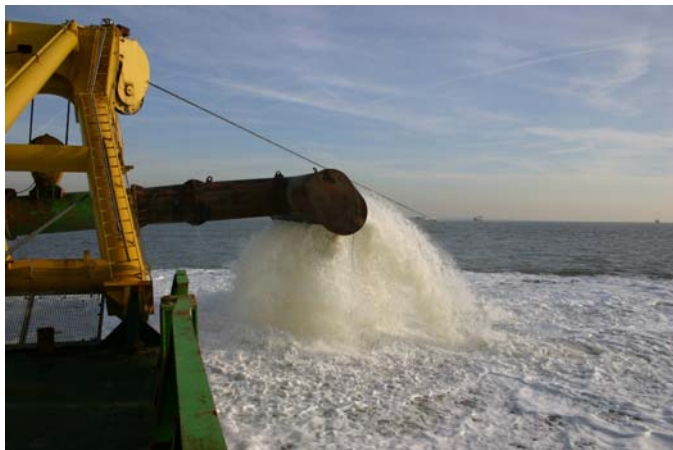
Fig. 10. Detail of the diffuser.

The execution of an *in situ* disposal test had to bring final proof of the feasibility of the alternative disposal strategy. The idea of the *in situ* test was to dispose quietly and precisely 500,000m³ of sand with a diffuser on the bottom. The dredging vessel (self-discharging hopper dredger) was connected to a floating pipeline through which the sand is transported to a pontoon 'Bayard II' (Fig. 6). On this pontoon the sand is pumped to a diffuser (Fig. 10) that disposes the sediment in a precise way on to the bottom. The use of the diffuser required an adjustment of the disposal license. The amount of 500,000m³ was chosen because it is on one hand large enough to affect significantly the bottom morphology, however on the other hand small enough to be reversible if something would go wrong. The choice of the disposal location was based on the results of the feasibility study. The float measurements, the results of the numerical simulations and the physical scale model tests with moveable material on fixed bed indicated that an area between the northern sand spit and the tip of the plate was most suitable for an *in situ* disposal test (Fig. 11). From 17 November to 20 December 2004, 500,000m³ of sand was almost continuously disposed in the proposed area.
